NILES QUADRANGLE

MAP OF QUATERNARY FAULTING ALONG THE NORTHERN CALAVERAS FAULT ZONE

by Darrell Herd

1978

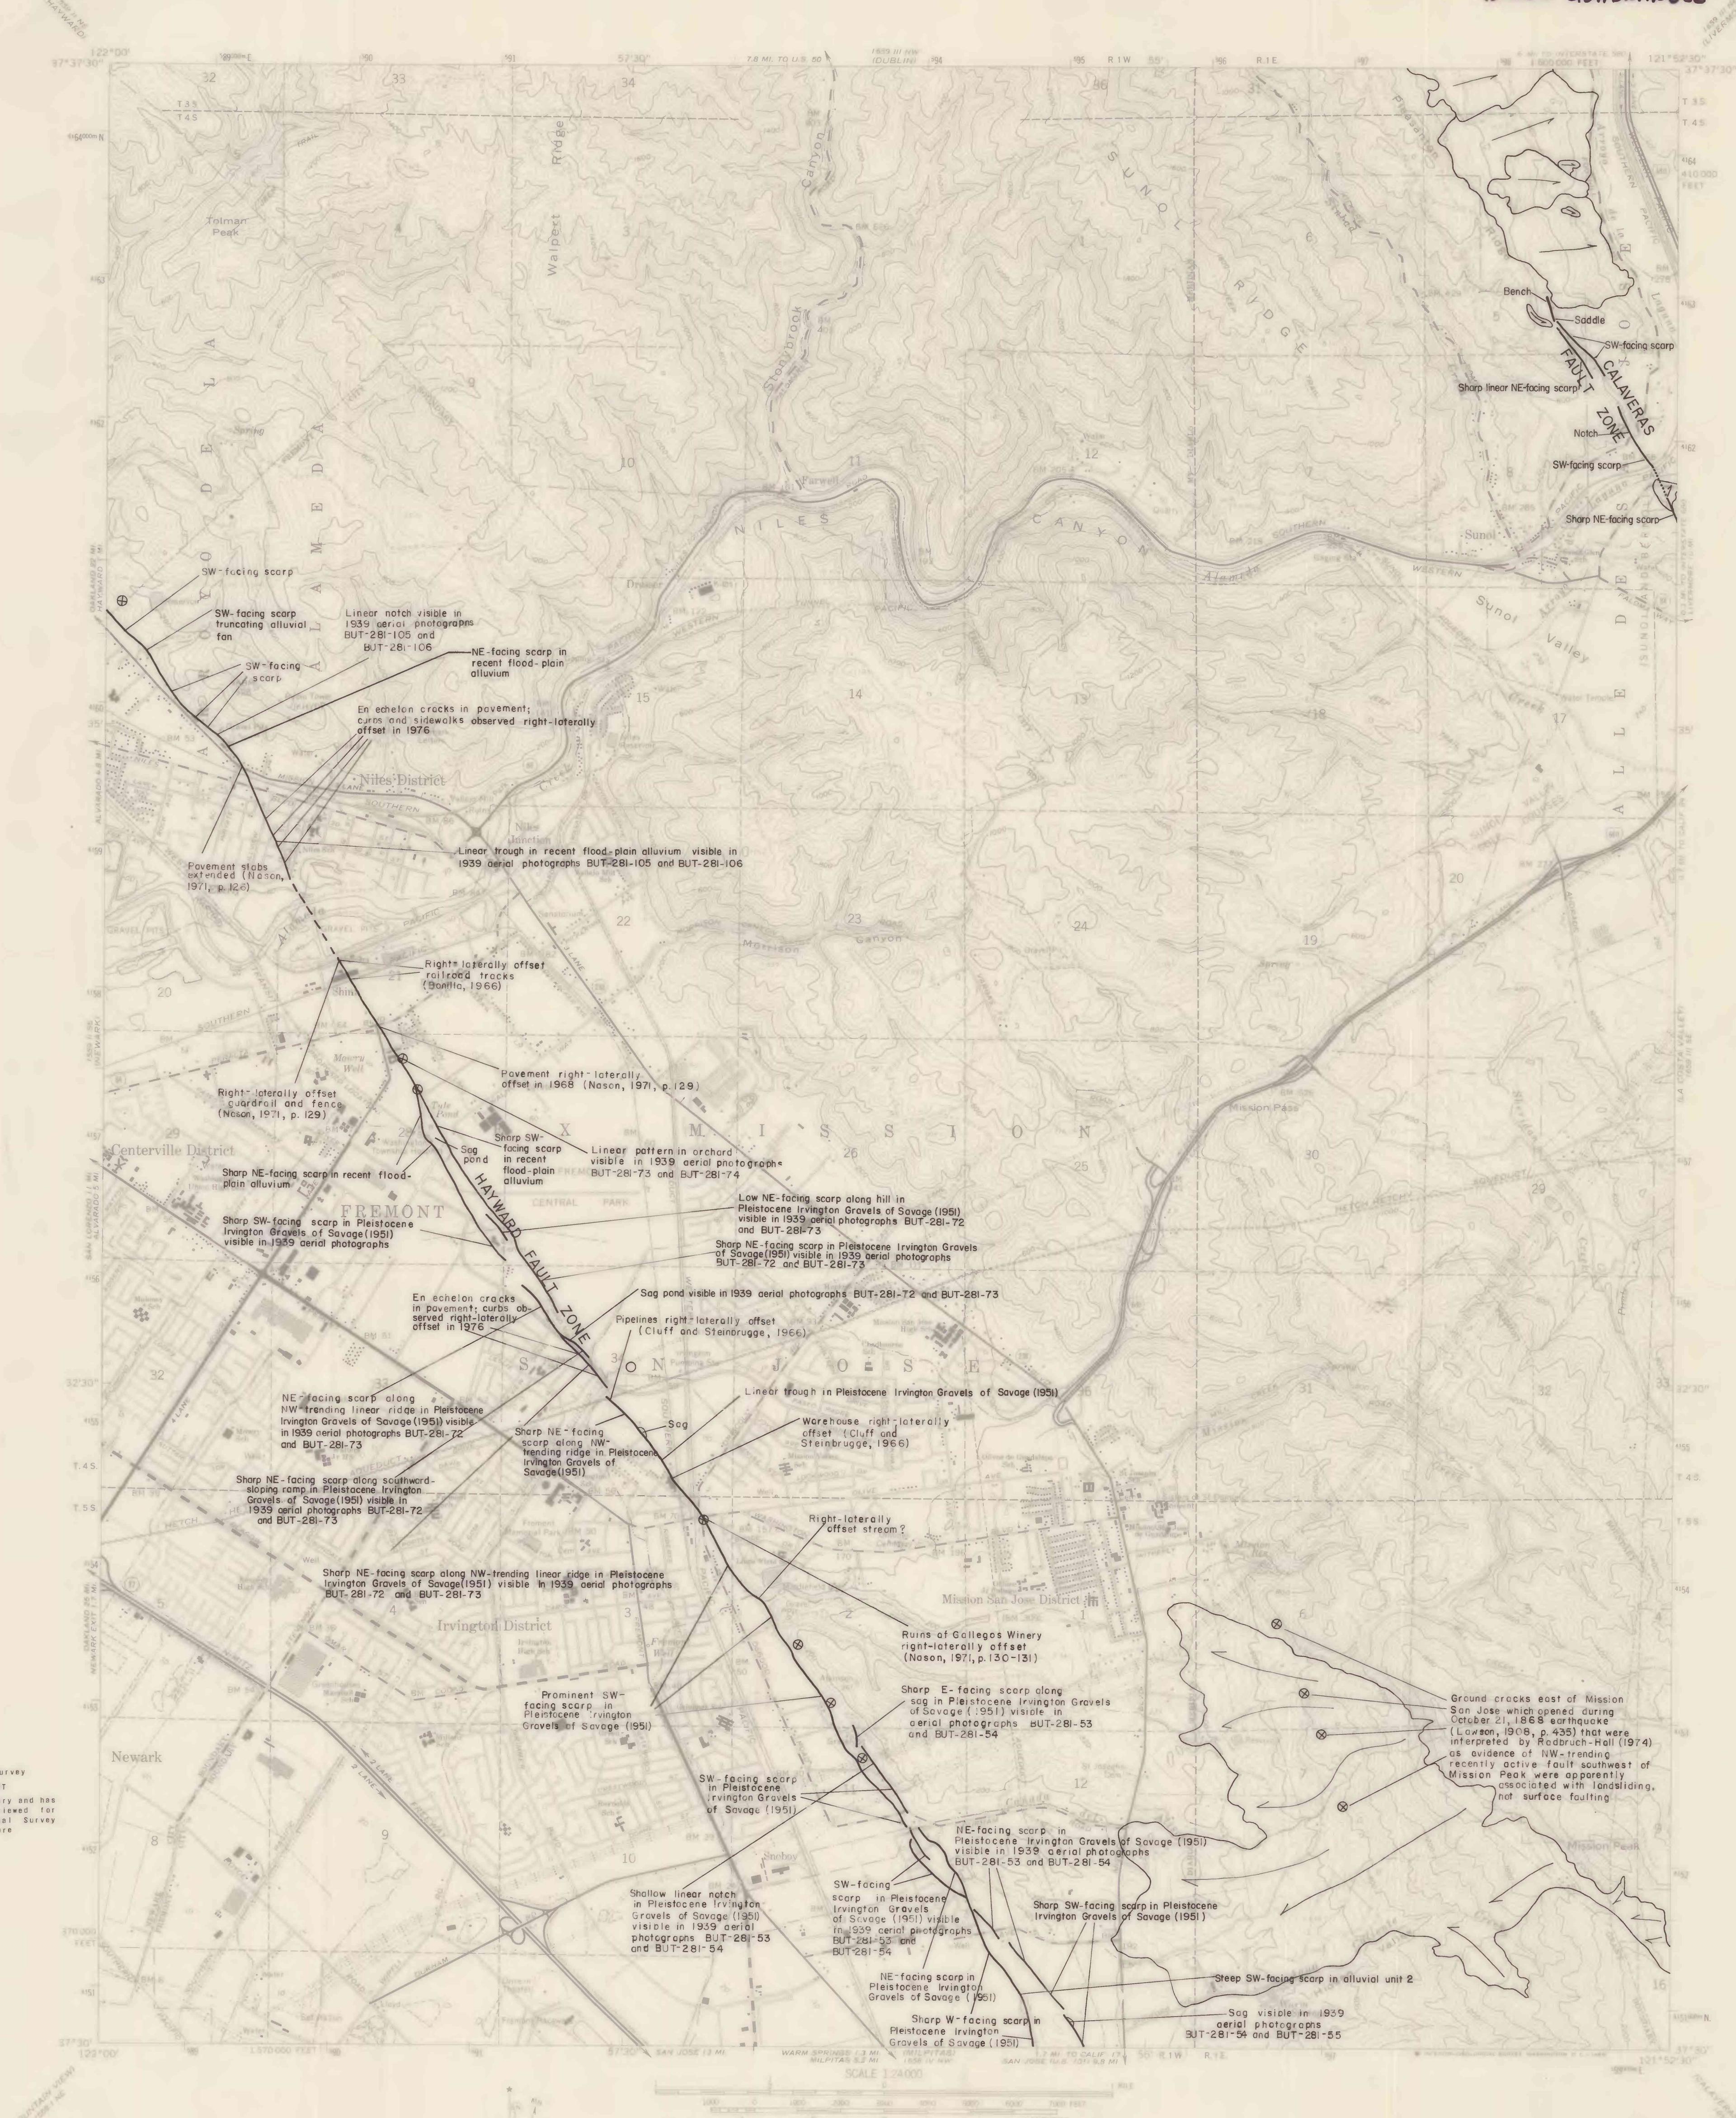
Location of cracks formed during the earthquake of October 22, 1968.
(Redbruch-Hall, 1974)
